**Presented to the:**  
**New Jersey Board of Public Utilities**

## **Final Report**

**Focused Audit of the Planning,  
Operations and Maintenance Practices,  
Policies and Procedures of  
Jersey Central Power & Light Company  
Docket No. EX02120950**

**June 22, 2004**

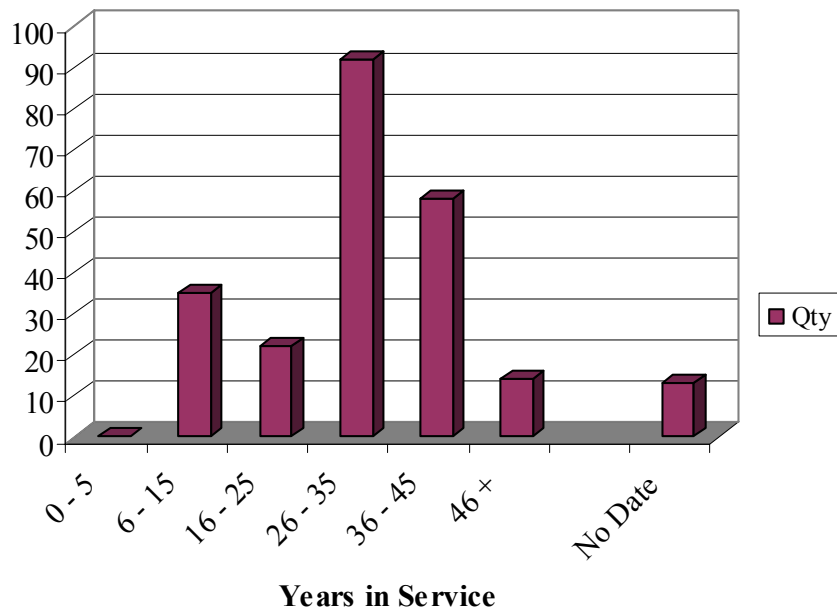
**Figure 2**  
**Distribution Transformer Age**  
**JCP&L Northern Region**

Substation equipment on the JCP&L system is older than we normally observe on other electric utilities in the 38 states Booth provides services. The following *Figure 2* shows transformer ages for the Distribution Transformers located in the Northern Region:

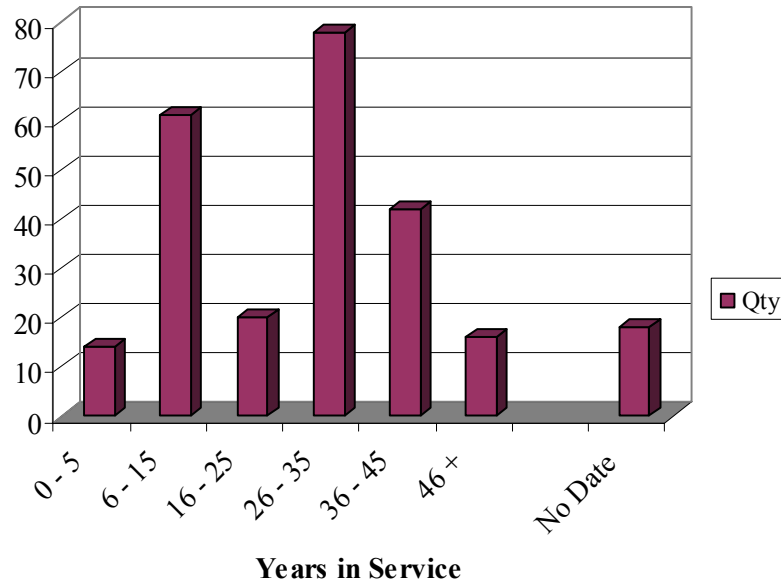
**Figure 3**  
**Distribution Transformer Age**  
**JCP&L Central Region**

Figure 3 shows similar information for the Central Region:

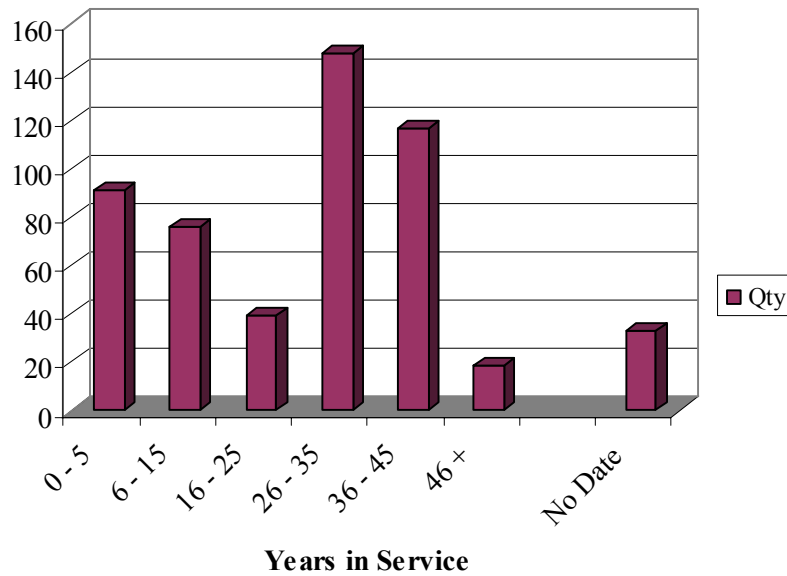
**Figure 4**  
**Northern New Jersey Region Circuit Breakers**

Fifty-four percent (54%) of the circuit breakers exceed twenty-five (25) years in service.

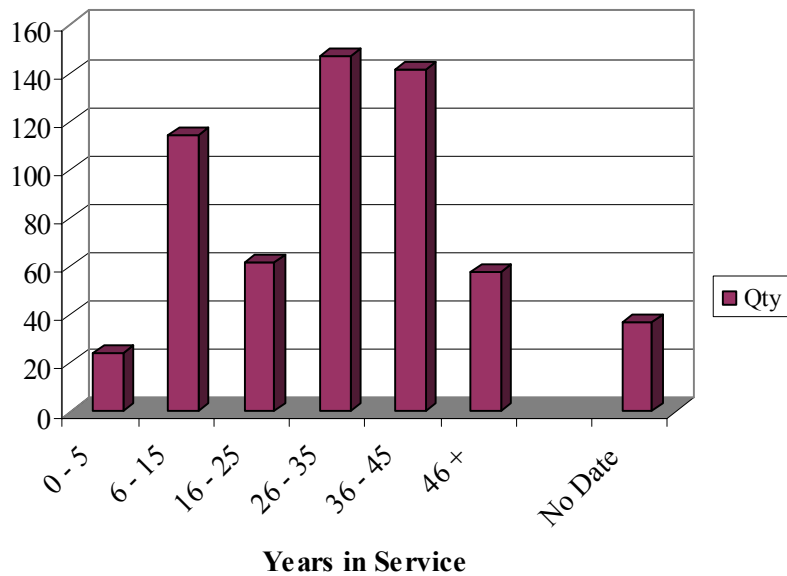
**Figure 5**  
**Central New Jersey Region Circuit Breakers**

For the Central Region, fifty-nine percent (59%) of the circuit breakers exceed twenty-five (25) years in service.

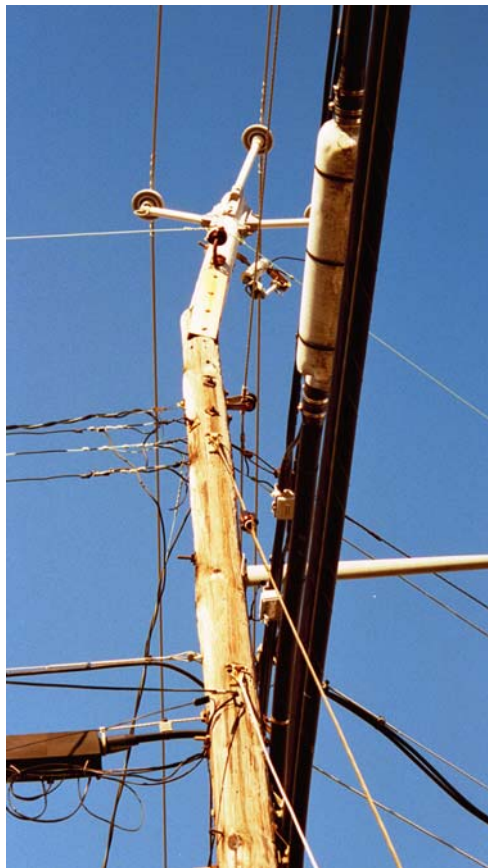
*Photo 6*

Pole heights were increased and circuits were added to the top of existing poles by bolting a pole extension (part of a wood pole) to the top of an existing pole. This was done in lieu of replacing the old pole with a taller and larger class (diameter) pole and does not comply with the NESC (Sections 25 and 26). (See Photos 6 and 7) This practice represents a safety and system reliability risk. In most cases it exposes major feeders to higher risk of storm-related outages, including low to medium speed winds up to 50 mph.

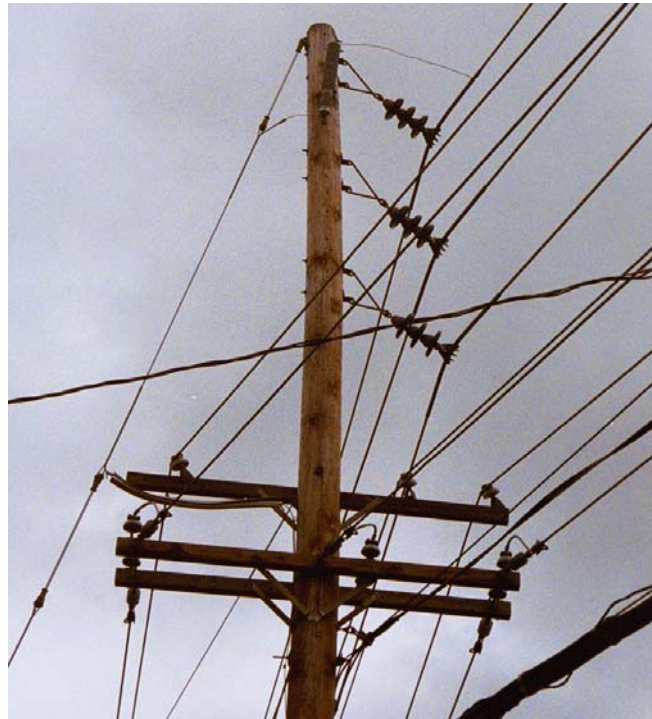
**Photo 10**

1. There were instances where guy wires were used to ground the surge arresters installed on the top phase (see photo 10).

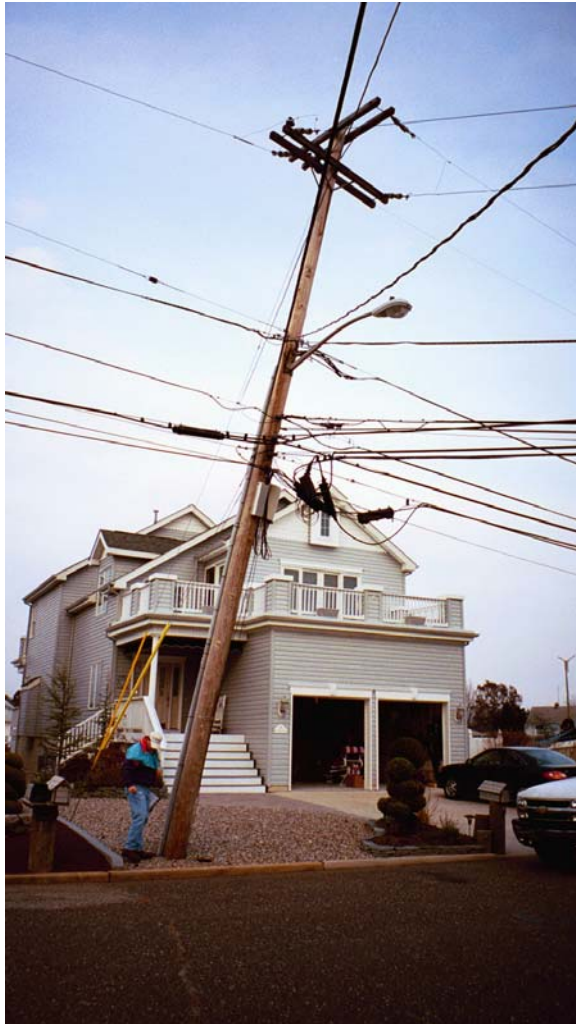
*Photo 11*

1. JCP&L construction standards have not been used for guying their angle and dead-end structures. Most guy leads are too short. Not all locations that need guying are guyed. Inadequate number of guys and anchors is prevalent.
2. Push pole bracing observed was installed too high on the pole. This causes the pole to deflect at the top and the brace pole to bow in the center.
3. Guys are not grounded and guy strain insulators are not consistently used in guys.
4. Pole loading on joint-use poles is excessive, and engineering analysis is clearly not being performed prior to attachment of CATV and telephone cables (see photos 11 and 12).
